Collision

The International Compendium for Crash Research

HIGH SPEED PEDESTRIAN COLLISION AND VERIFICATION OF CAR COLLISION SPEED IN PEDESTRIAN ACCIDENTS BASED ON BIOFIDELIC DUMMY INJURIES

ANNIKA KORTMANN AND TIM HOGER

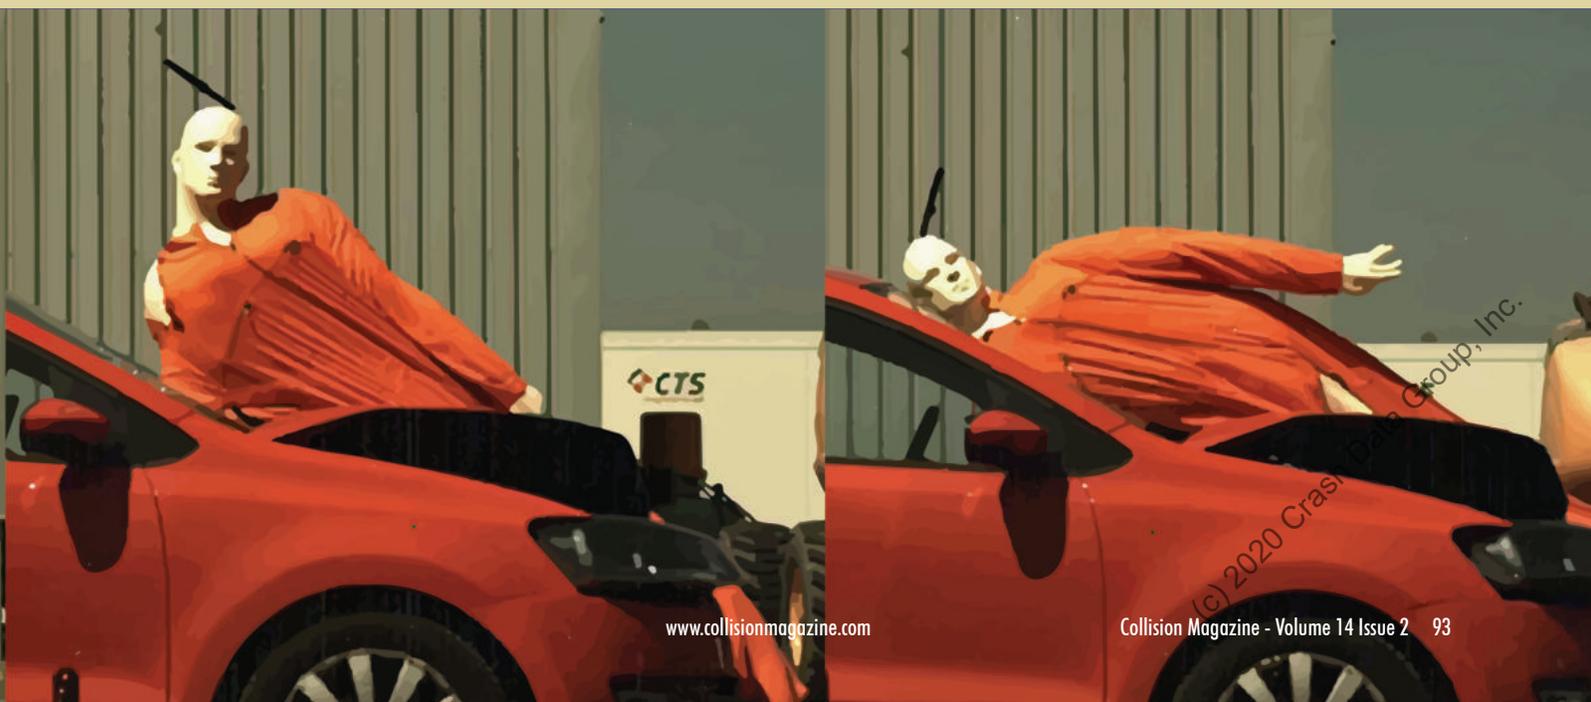
Figure 2: Motion sequence and rolling behavior of the Biofidel dummy at $v = 80$ kph.

The rolling movement of a pedestrian in a collision with a passenger car is known, as shown in the side view in figure 2 in individual images. The crash attempt shows a biofidelic dummy, which was laterally impacted at a velocity of 80 kph. The rolling behaviour of the dummy begins when the dummy is positioned with the hips almost half way between the vehicle front and the lower edge of the windscreen. A typical lateral shearing movement of the head occurs in the direction of the windscreen.

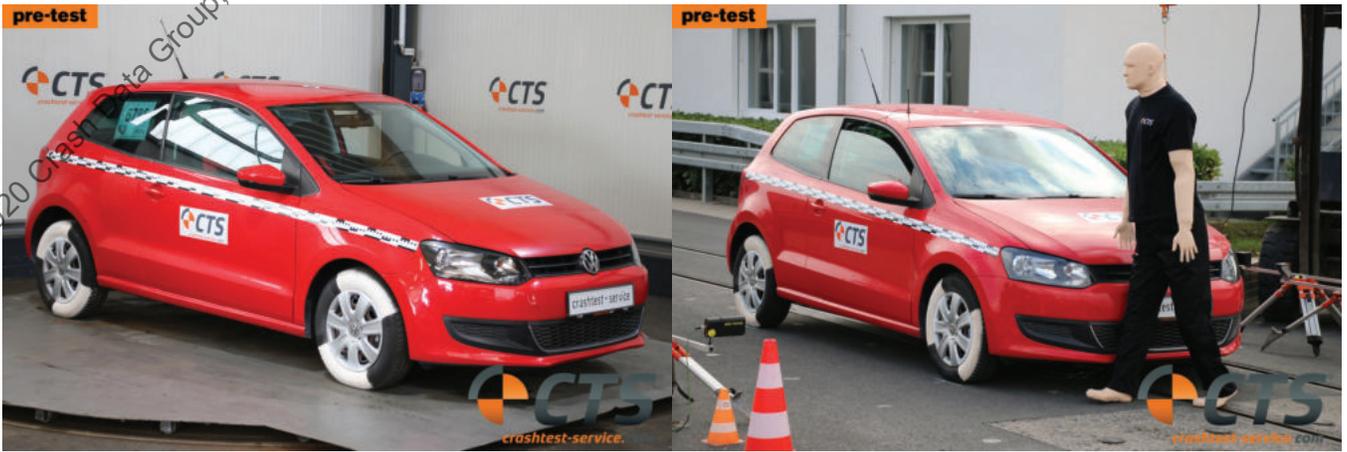
Figure 1: Crash vehicle VW Polo 6R (left) and impact situation with Biofidel dummy (right) for the high-speed test with $v = 109$ kph

To also be able to provide information in the high speed range ($v > 100$ kph), as part of an expert seminar by crashtest-service.com GmbH, the crash test series with the VW Polo 6R and the biofidelic dummy was supplemented with a collision speed of 109 kph. Thus, the relationship between passenger car damages and pedestrian injuries be can extended. Additionally, it is possible to check whether at high collision speeds the postulate tears according to Appel et. al. ² between the leg and torso also occurs to the biofidelic dummy. Similarly to the previous crash test series, the dummy was also impacted laterally in the high speed crash test. The point of impact on the passenger car was situated in the centre of the bonnet, figure 1.

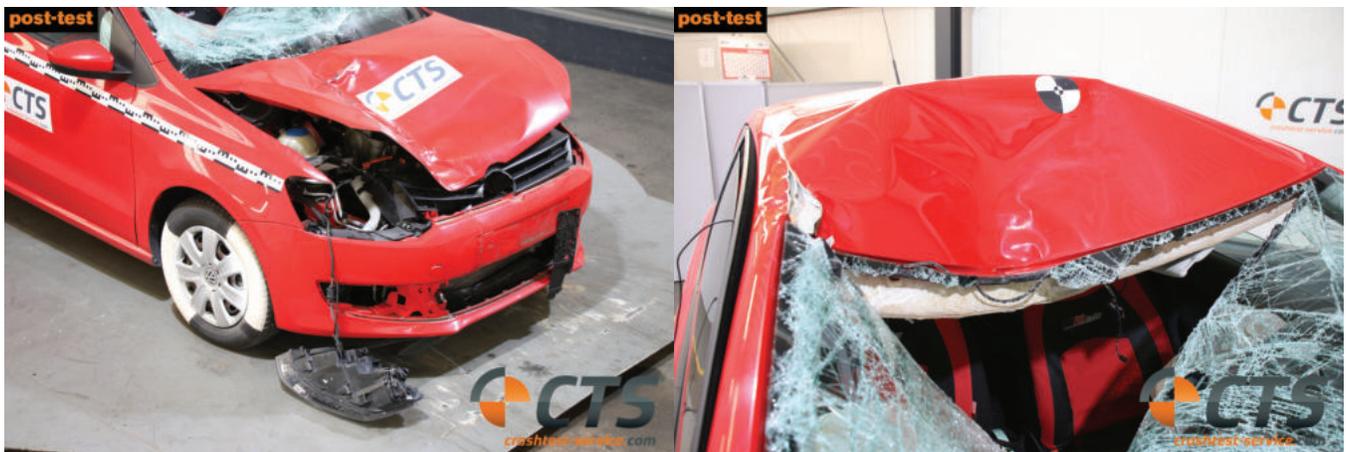
Figure 4: Hood and roof damage on the VW Polo at $v = 109$ kph.

The damage caused to the passenger car at a collision speed of 109 kph is exemplarily portrayed in the two images in

figure 4. In the left image the hip impact of the dummy is visible, which ends just before the lower edge of the front windscreen. Up until this point, the upper body of the dummy tilted less than 5° , so almost upright.

The front bumper covering appears to be undamaged except for the missing grill and lighting units. The head impact on the roof can be retraced through the deep deformation as shown in the right image of figure 4.

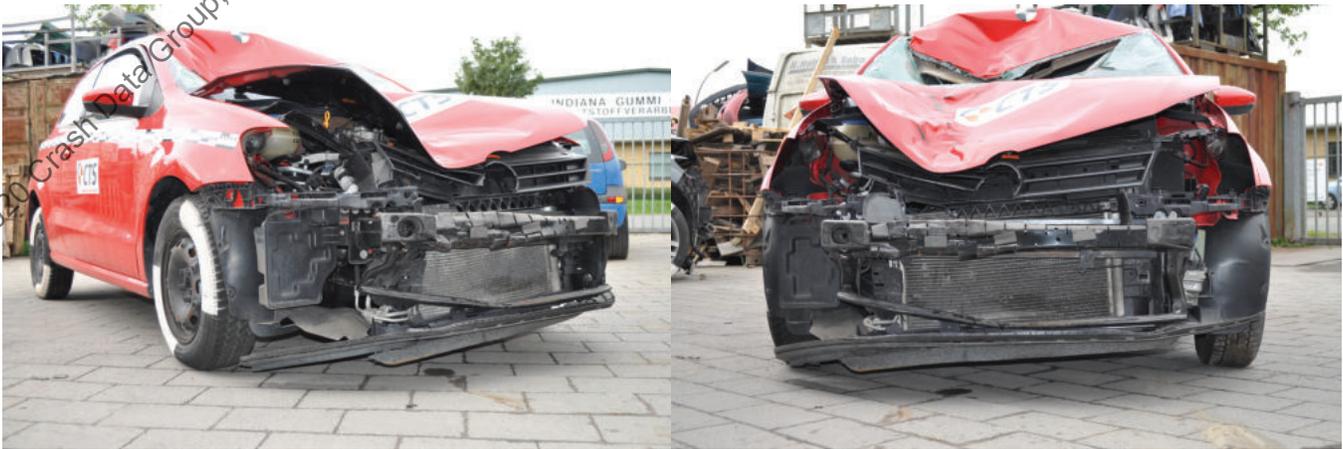
Figure 5: Damage of the VW Polo after dismantling the bumper cover

Upon disassembly of the front bumper cover, the profound intrusion of the vehicle's crossmember is apparent, see figure 5. The lower crossmember, which should prevent the undergoing of the feet, was (in the direction of travel) bent inwards as far as the radiator at the right side. The left side of the lower crossmember remained fully intact, figure 6.

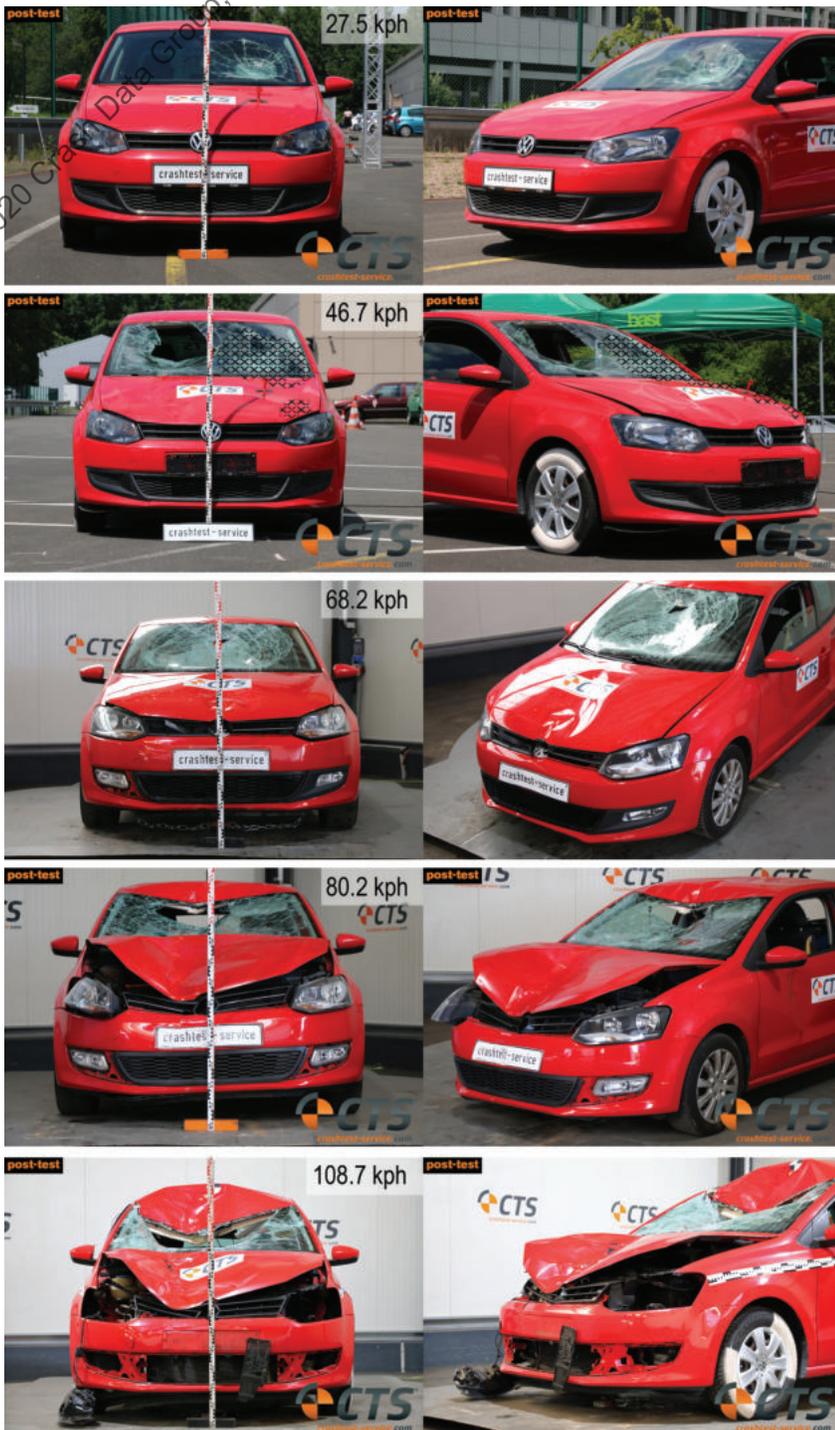
Figure 7: Change in the damage pattern (impact against Bio-fidel) on the VW Polo 6R with increasing speed from 27.5 to 108.7 kph in the front and side view

The exact stand position of the dummy at the first point of contact can also be seen through the deformation of the upper main front crossmember. The disassembly of the front bumper cover is therefore essential in order to identify the exact impact configuration. Figure 7 shows the damage incurred to the VW Polo of the

previous crash test series with increasing collision speed in the range between 28 and 80 kph, which is supplemented now by the high speed crash attempt at 108.7 kph.

As a result of the largely elastic deformation of the front bumper cover, the grill and the lighting units came off the vehicle's front. The higher speed results in a significant intensive deformation of the bonnet, a penetration of the front windshield and compression of the roof.

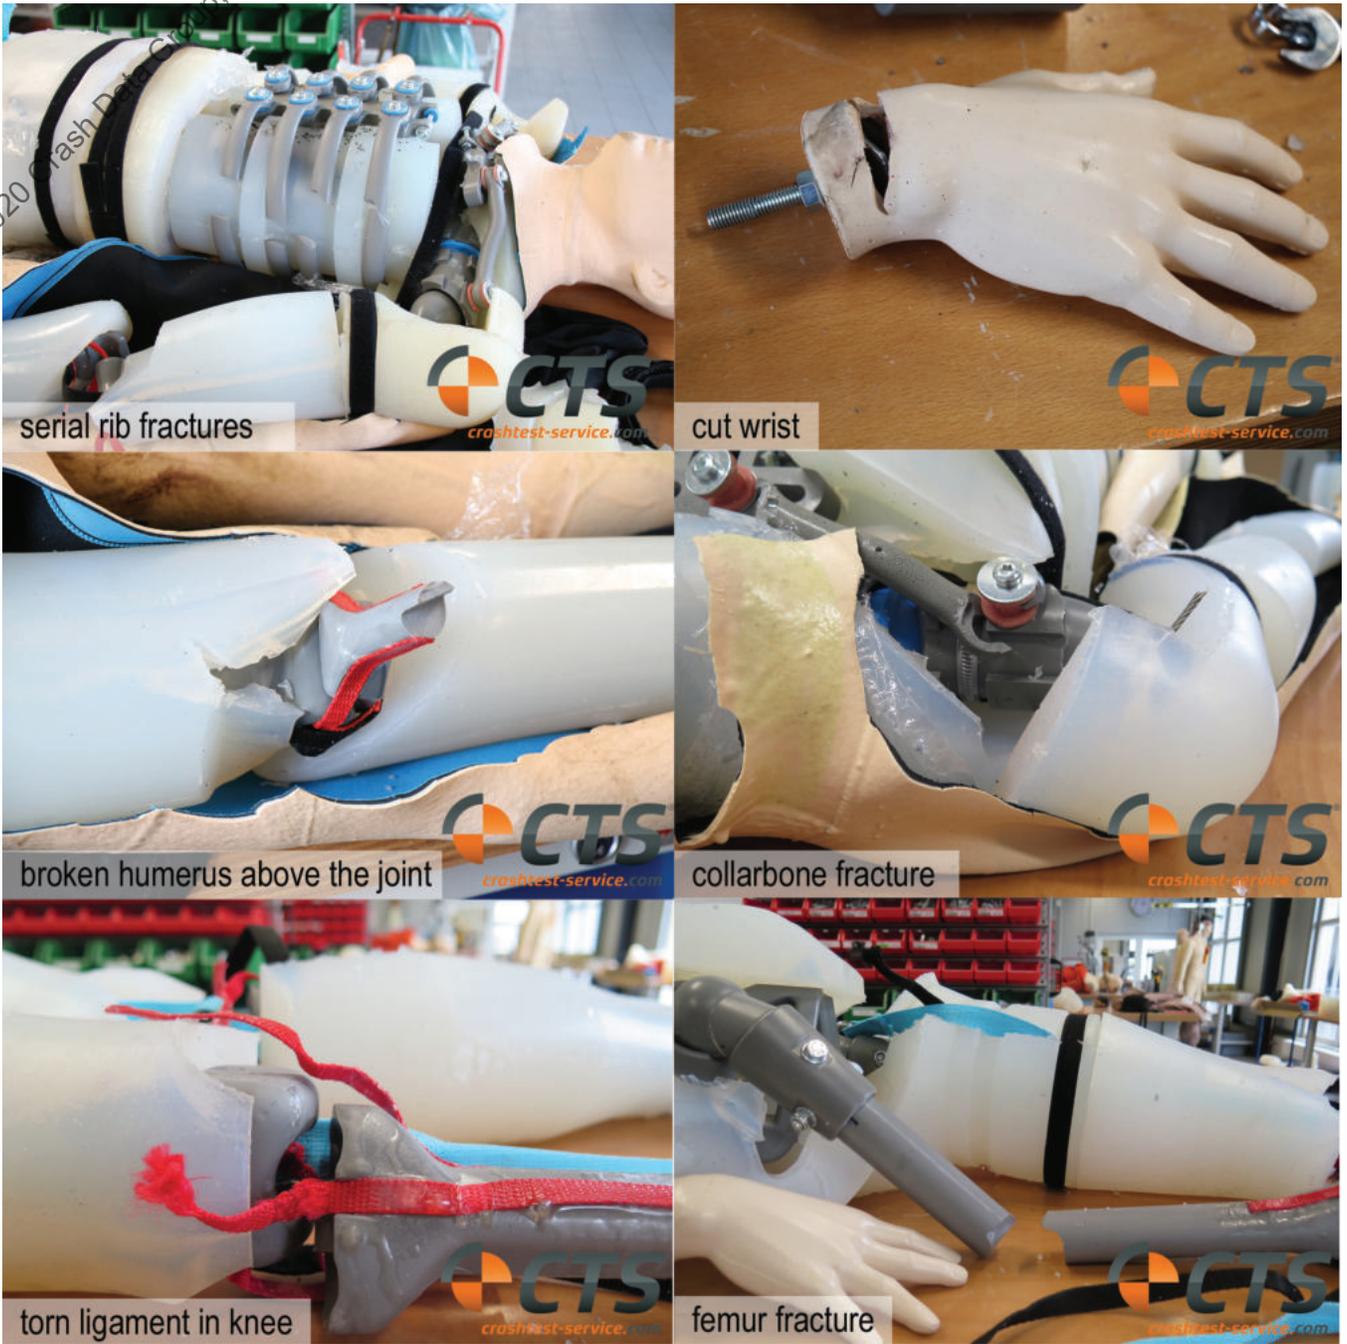
Figure 9: Investigation of a Biofidel dummy

ment injuries and also fractures of the bone can be documented. Photographic material of a typical dummy examination is shown in figure 9.

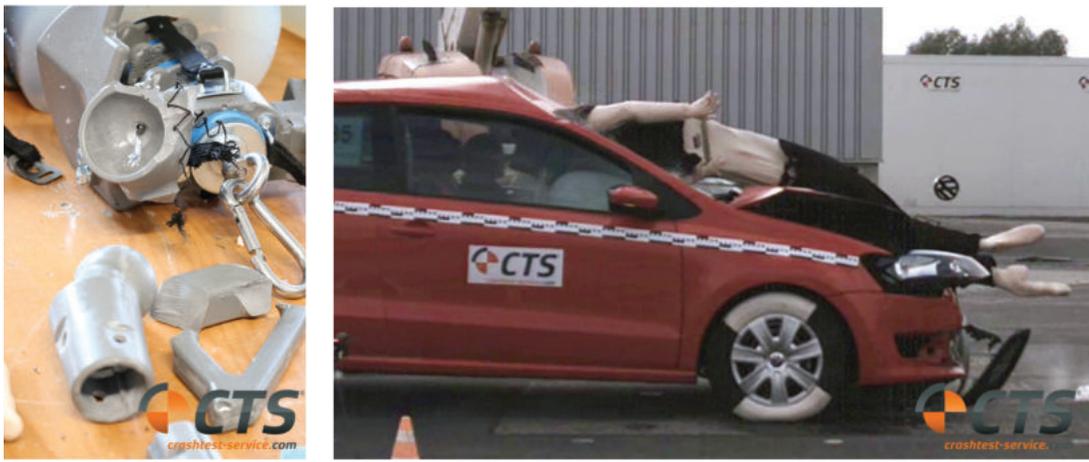
Figure 11: Massive hip damage (left) and severe dummy elongation during collision (right)

Analysing the movement sequences of the biofidelic dummy at a collision speed of approximately 109 kph in regard to the massive damage to the hips and femur, it becomes apparent in figure 11 that the hip area of the dummy is extremely elongated between torso and leg. Due to the high elasticity of the dummy's skin, the upper body had not been separated from the legs, although the hip bones were shattered and the femur bones placed out of the hip socket. In the case of real accidents, it can be assumed that with the same injuries it would have resulted in an amputation of the legs during the collision. There is still development potential in this area, so that a tearing of the dummy can also occur.
